Restoration of St. Mary's Church

Maticka Praha

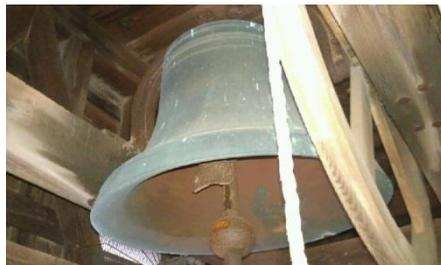
The Church Bells

The three rope pulled bells which had not rung in years because the air handlers were installed next to them in the bell tower are now digitally

controlled. They ring automatically at 6 a.m., noon, 6 p.m. and after Sunday Mass to the glory of God. They can be heard miles away.

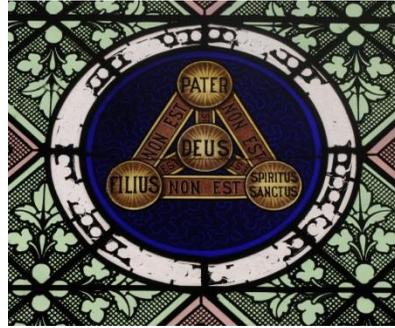
The Stained Glass Windows

In the past multiple repair works were undertaken on the windows to address the bowing of the windows.

The failed paint work, the broken and mismatched replacement glass pieces were all indicators that the stained glass windows were in decline. The work done by Foster Stained Glass, Bryan includes the removal of the metal frames around the windows. Wooden window frames have been installed as originally designed. The original pieces of stained glass that were in good shape were conserved. The broken ones were replaced with new pieces of glass. The stained glass windows are now re-leaded and repainted. The process has restored the stained glass windows to their original configuration.

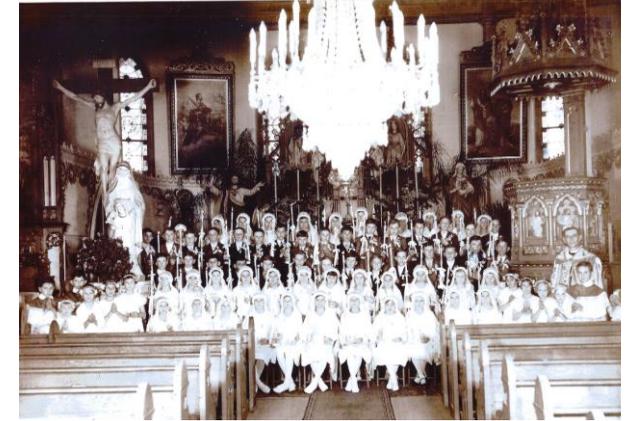
The Reredos, The Ambo and The Communion Rail

The three reredos (altars), the Ambo and the communion rails were stripped and repainted with oil base white enamel paint and patinaed. These original pieces of the Church are gilded in twenty-four Karat gold leaf. The canopy of the Ambo is a replica of the original. It was designed and rebuilt by Ernest Chaloupka, Jr. and George Kalisek of Moulton.

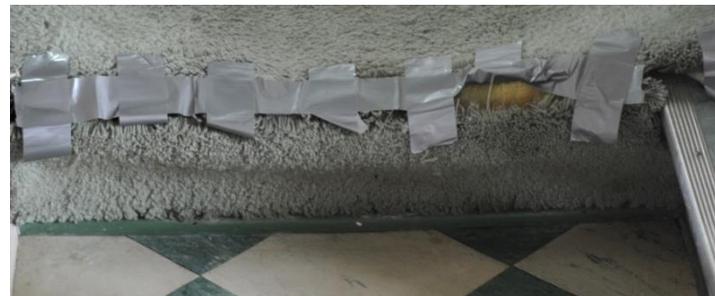
The Floor of the Church

With the green and white vinyl floor tiles removed, the floor now showcases the original quarter-sawn long leaf pine wooded floor. The wood has been sanded and refurbished to its original beauty by R. B. Construction, Moulton and Bobby Klatt of Victoria Floor Surfacing.
