Restoration of St. Mary's Church

Maticka Praha

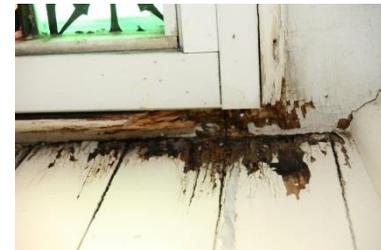
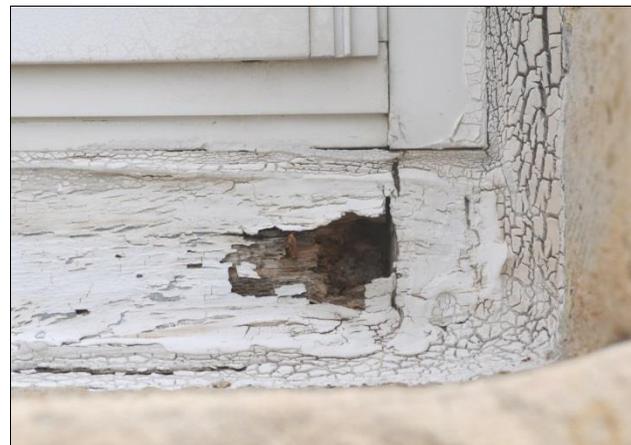
In the past multiple repair works were undertaken on the windows to address the bowing of the windows.

The failed paint work, the broken and mismatched replacement glass pieces were all indicators that the stained glass windows were in decline. The work done by Foster Stained Glass, Bryan includes the removal of the metal frames around the windows. Wooden window frames have been installed as originally designed. The original pieces of stained glass that were in good shape were conserved. The broken ones were replaced with new pieces of glass. The stained glass windows are now re-leaded and repainted. The process has restored the stained glass windows to their original configuration.
